VEDANTA'S COMMITMENT TO SUSTAINABLE TAILINGS MANAGEMENT

FACT SHEET – FEBRUARY 2019

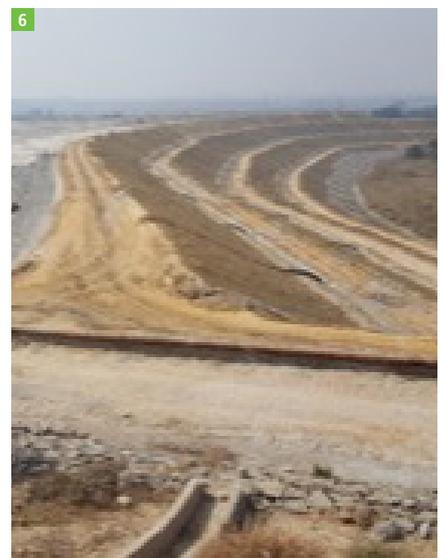
- Excellent documentation, quality remedial construction, and overall ash management. Lagoon 3, shown left with multiple deposition points from perimeter slurry line
- Successful rehabilitation and raising of Pond 1 is a testimony to the Jharsuguda Ash Team's efforts in stabilizing Lagoon 1 and developing capacity for future ash storage

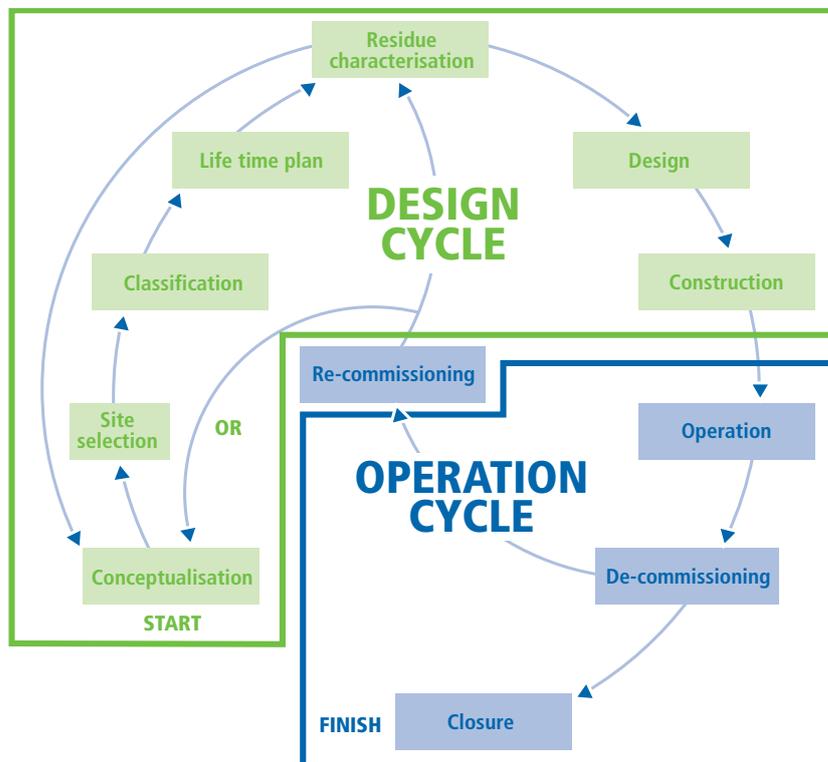
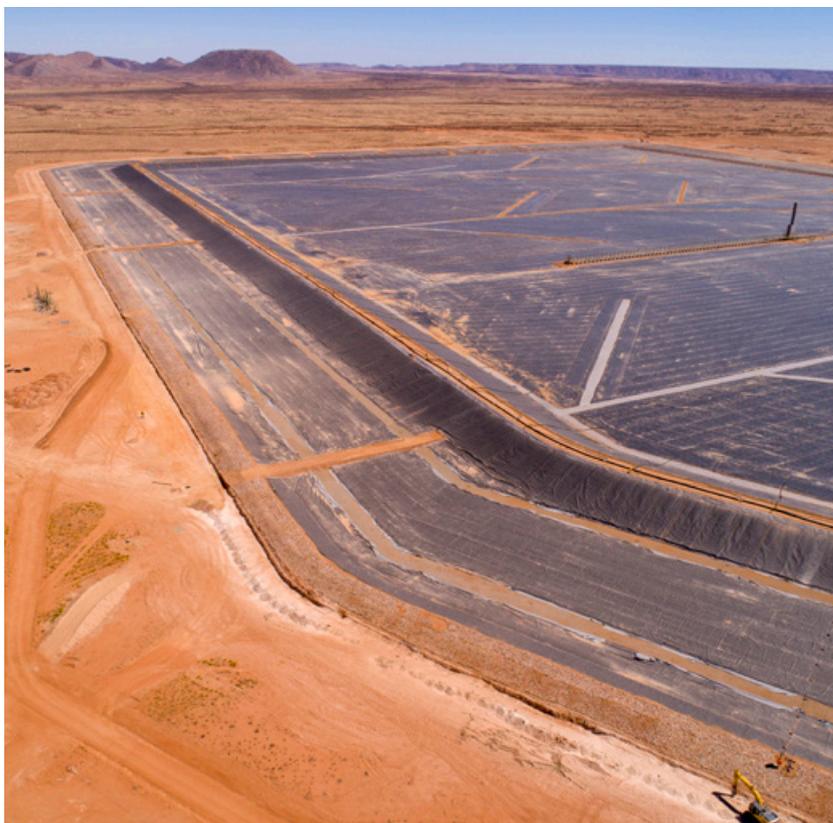
OVERALL PROJECT EXECUTION MODEL Lifecycle framework for residue deposits
